# Road Safety Assessment

Cass Avenue | Woonsocket, RI

SEPTEMBER 2018

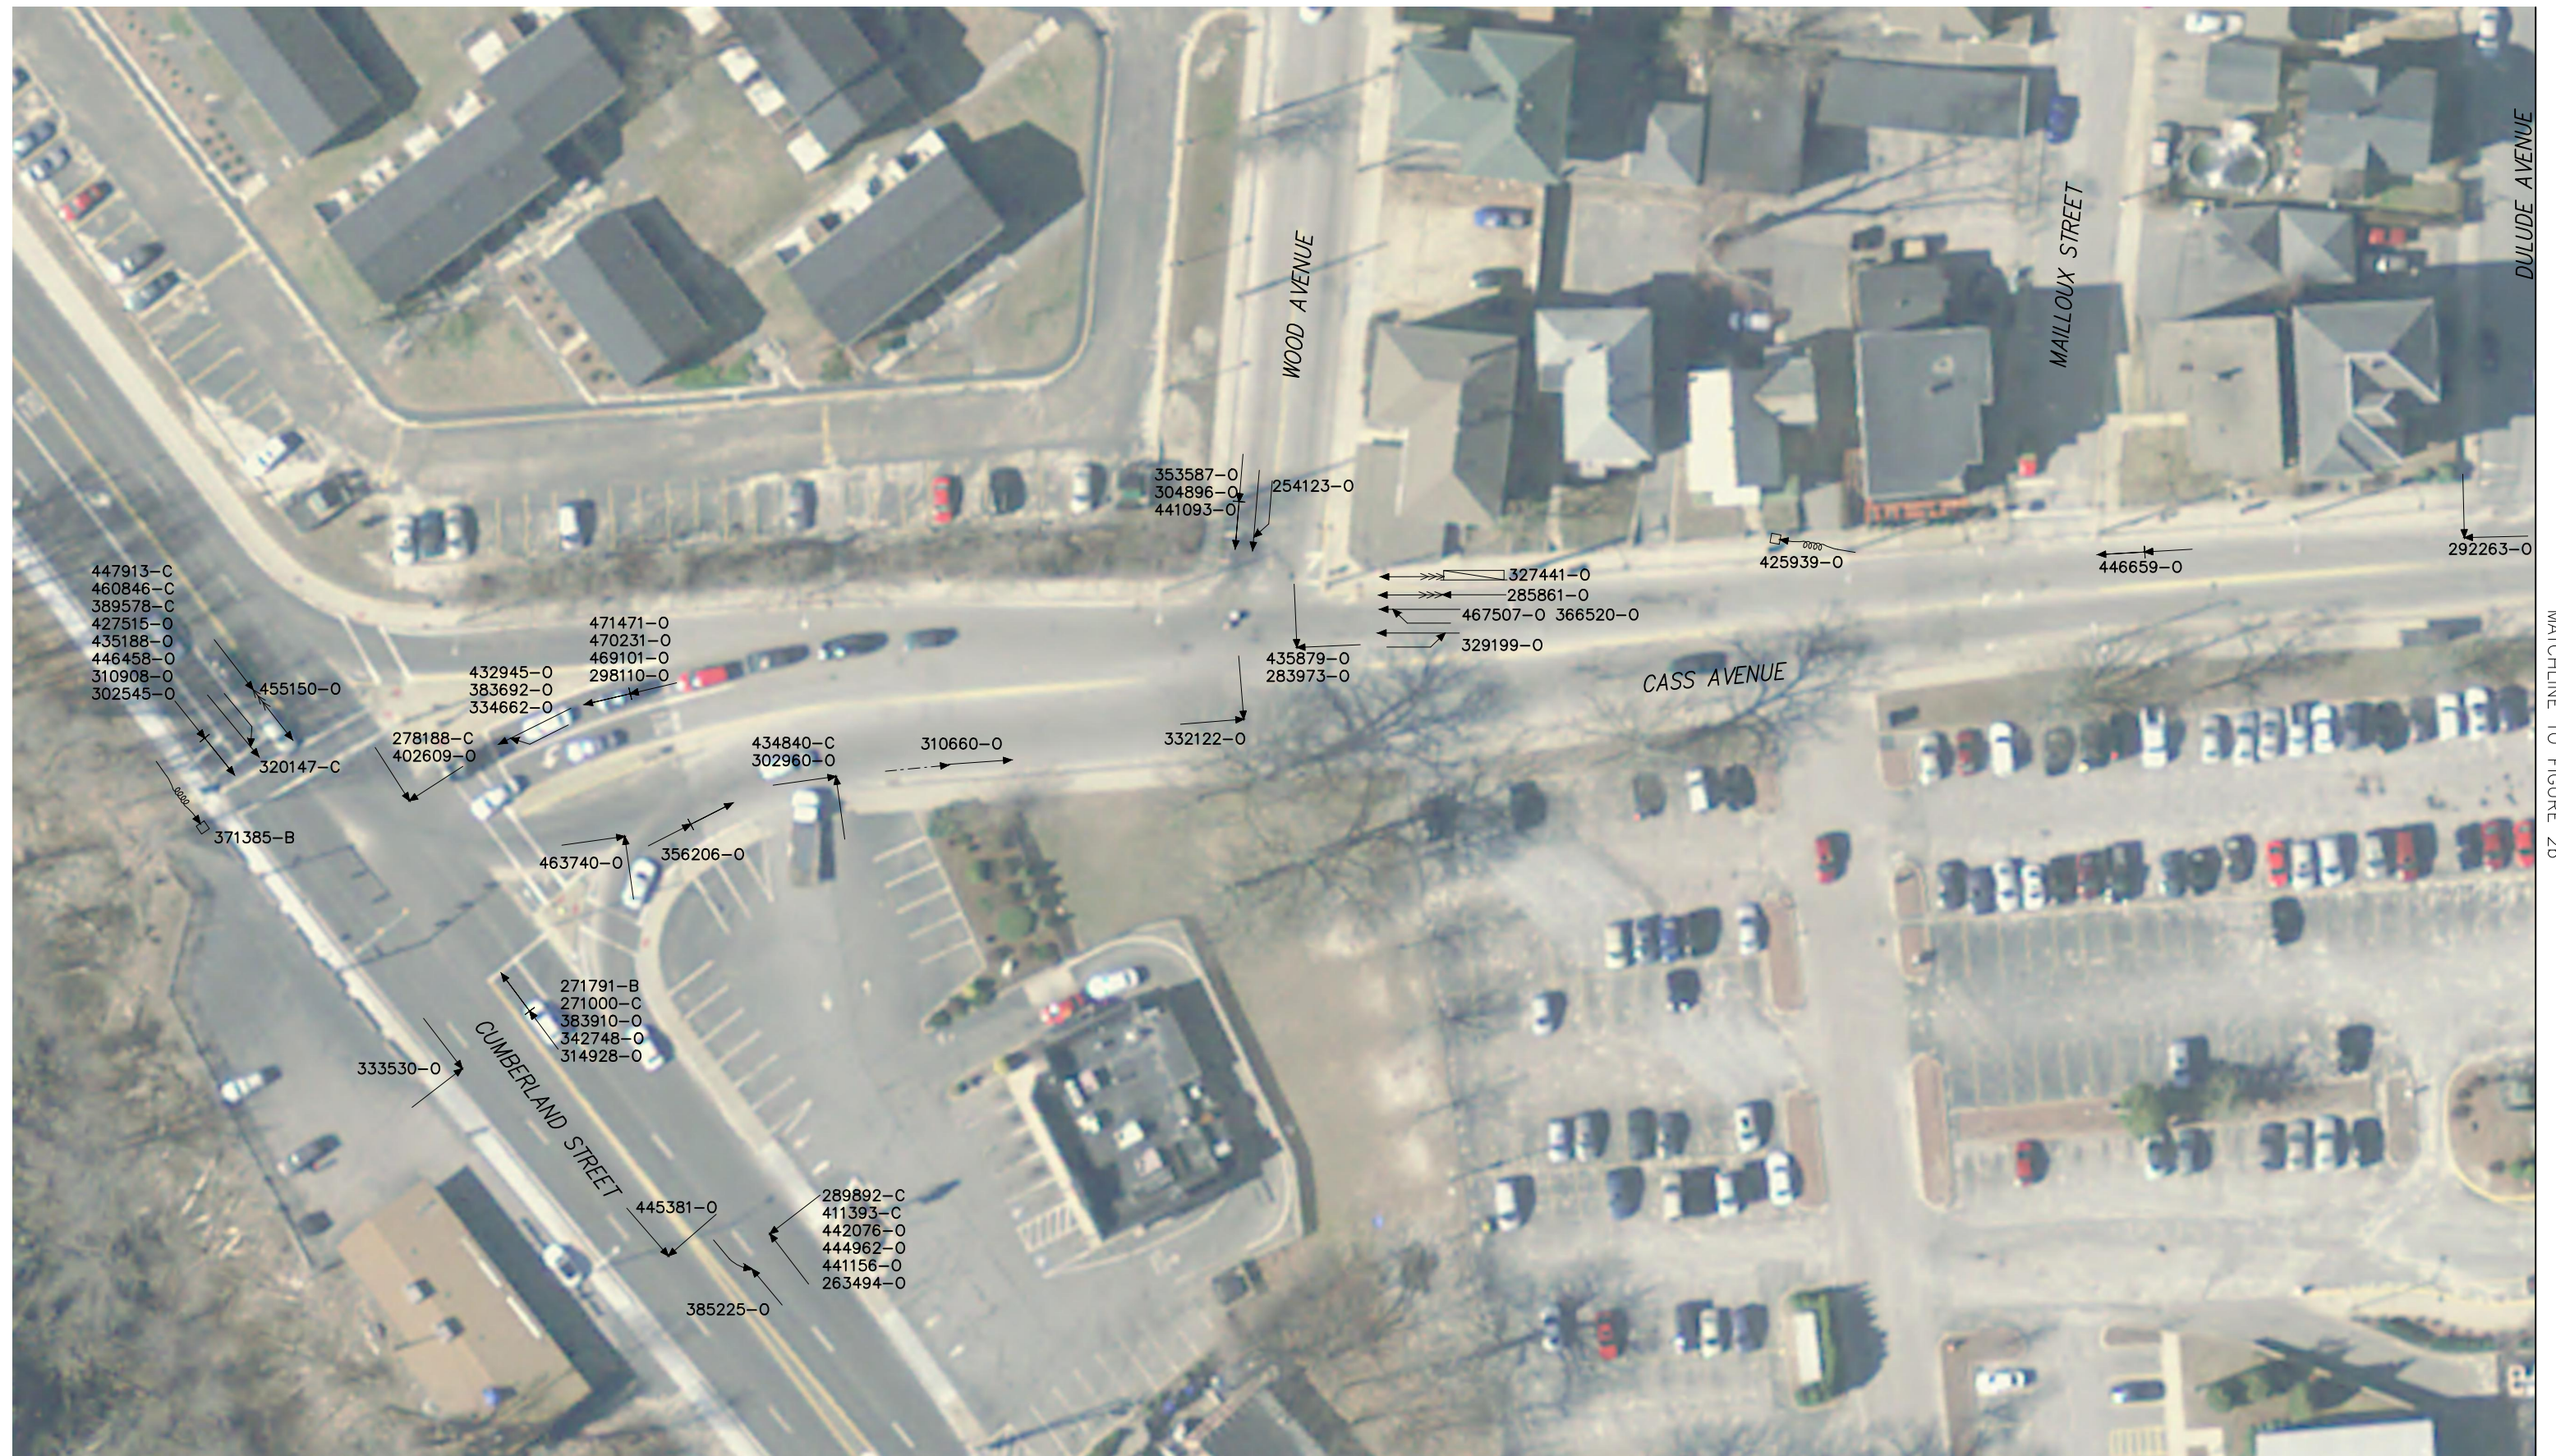
Figure 2-1a

Along Cass Avenue, there were 131 crashes that occurred from 2013 through 2017. One of those crashes (<1%) was a K-type crash, one crash (<1%) was an A-type crash, five of the crashes (4%) were B-type crashes, twenty-seven of the crashes (21%) were C-type crashes, and the remaining 74 percent of crashes resulted in property damage only. The most common type of crash between two vehicles were rear-end type incidents, accounting for 40% of the total crashes. Angle crashes (side impacts) also occurred frequently, making up 33% of the total crashes.

**Figure 2-1** provides a collision diagram detailing crashes along Cass Avenue between Cumberland Street and Mendon Road.

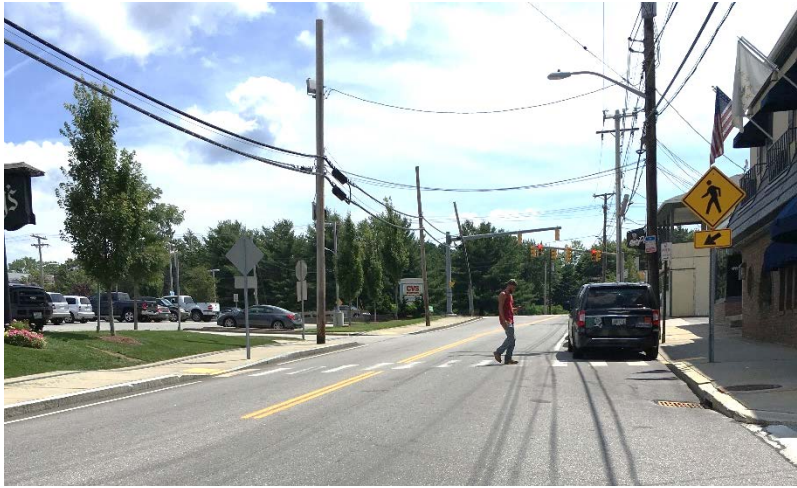
OBSERVATION	IMMEDIATE TERM IMPROVEMENTS Under 6 months	NEAR TERM IMPROVEMENTS Under 2 years	LONGER TERM IMPROVEMENTS Over 2 years	COMMENTS
<p><b>Inadequate Vulnerable Road User Facilities</b> – Cass Avenue runs alongside a medical center, a public park, and Woonsocket High School. The sidewalks and pedestrian crossings undergo constant use but currently lack the proper striping and advance sign placement. There were also several bicyclists observed on the corridor with no current marked facilities.</p>

<p><b>EDUCATION:</b></p> <p><b>1.14</b> Consider a “Yield to Pedestrians” educational campaign to instruct drivers to yield to pedestrians in crosswalks.</p> <p><b>ENFORCEMENT:</b></p> <p><b>1.15</b> Consider enforcement at adjacent on-street parking, east of Elm street, to discourage parking within the pedestrian access routes.</p> <p><b>ENGINEERING:</b></p> <p><b>1.16</b> Upgrade or replace all pedestrian and playground warning signs to fluorescent yellow-green and retroreflective.</p> <p><b>1.17</b> Install retroreflective panels on pedestrian warning sign posts for enhanced visibility.</p> <p><b>1.18</b> Trim overgrown vegetation along Cass Avenue that is limiting sight lines of pedestrian warning signs.</p> <p><b>1.19</b> Install pedestrian warning signage on Cass Avenue approaches to marked crossings.</p>	<p><b>ENGINEERING:</b></p> <p><b>1.20</b> Consider reducing existing lane widths through restriping to provide bicycle lanes in each direction.</p> <p><b>1.21</b> Review pedestrian signal equipment to determine deficiencies. Replace equipment accordingly.</p>	<p><b>ENGINEERING:</b></p> <p><b>1.22</b> Install ADA compliant wheel chair ramps and stripe continental style crosswalks on appropriate intersection approaches.</p> <p><b>1.23</b> Consider installing pedestrian curb extensions / bumpouts at intersections.</p>	<p><b>Longer-term improvements are intended to address persistent safety issues if observed in the future.</b></p>

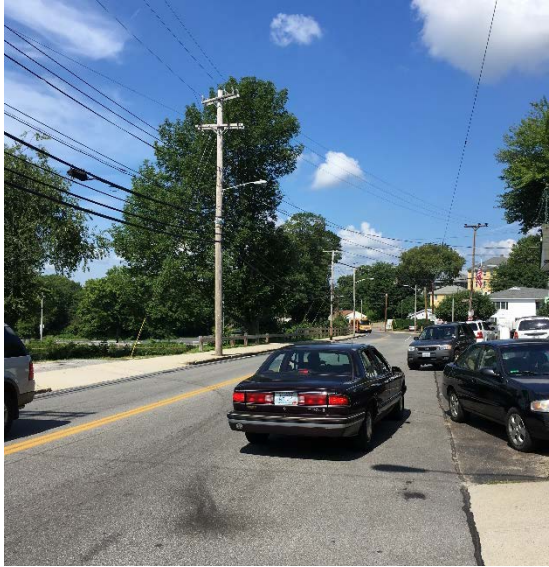
OBSERVATION	IMMEDIATE TERM IMPROVEMENTS <i>Under 6 months</i>	NEAR TERM IMPROVEMENTS <i>Under 2 years</i>	LONGER TERM IMPROVEMENTS <i>Over 2 years</i>	COMMENTS
<p><b>Inadequate Vehicle Sight Lines</b> – Inadequate vehicle sight lines occur at several intersections and segments along Cass Avenue due to the changes in elevation of the roadway, parked vehicles, and overgrown vegetation.</p>

<p><b>ENGINEERING:</b></p> <ul style="list-style-type: none"> <li><b>1.24</b> Install hatched pavement markings at crosswalks, side streets, and fire hydrants to restrict parking per RI state law.</li> <li><b>1.25</b> Review parking restriction signage and revise accordingly.</li> <li><b>1.26</b> Consider conducting a parking study to determine use and need.</li> <li><b>1.27</b> Remove parking spaces directly next to side street and driveway intersections along Cass Avenue that may interfere with sight distance per RI state law.</li> <li><b>1.28</b> Trim overgrown vegetation along Cass Avenue that is limiting sight lines at side streets and driveways throughout the corridor.</li> <li><b>1.29</b> Consider enforcement at adjacent on-street parking, east of Elm Street, to discourage parking that inhibits vehicle sight distance.</li> </ul>

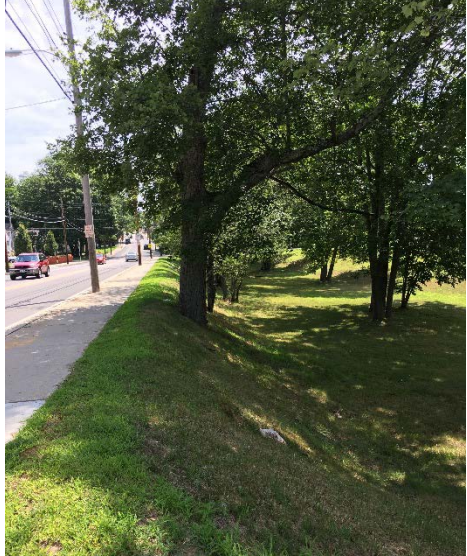
OBSERVATION	IMMEDIATE TERM IMPROVEMENTS <i>Under 6 months</i>	NEAR TERM IMPROVEMENTS <i>Under 2 years</i>	LONGER TERM IMPROVEMENTS <i>Over 2 years</i>	COMMENTS
<p><b>Sub-standard roadside barrier</b> – Roadside objects and non-recoverable slopes were observed to be within the clear zone on Cass Avenue intermittently from south of Elm Street to Ricard Street.</p>

<p><b>ENGINEERING:</b></p> <p><b>1.30</b> Evaluate the existing conditions along the corridor to determine if the current guardrail installation is appropriate.</p>	<p><b>ENGINEERING:</b></p> <p><b>1.31</b> If the existing wood fencing system is not appropriate, install steel w-beam guardrail to shield objects within clear zone.</p> <p><b>1.32</b> Consider the installation of w-beam guardrail to shield trees and slopes within the clear zone in front of Woonsocket High School.</p>		
<p><b>Night-time crash history</b> – Multiple crashes along Cass Avenue occurred during the night-time. There may be insufficient existing lighting installed along the corridor.</p>	<p><b>ENGINEERING:</b></p> <p><b>1.33</b> Conduct a street lighting study to determine deficiencies and potential improvements.</p>	<p><b>ENGINEERING:</b></p> <p><b>1.34</b> Review corridor-wide street lighting and implement any improvements necessary to ensure safety for vehicles and vulnerable road users.</p>		<p><b>Coordinate with National Grid for lighting improvements.</b></p>

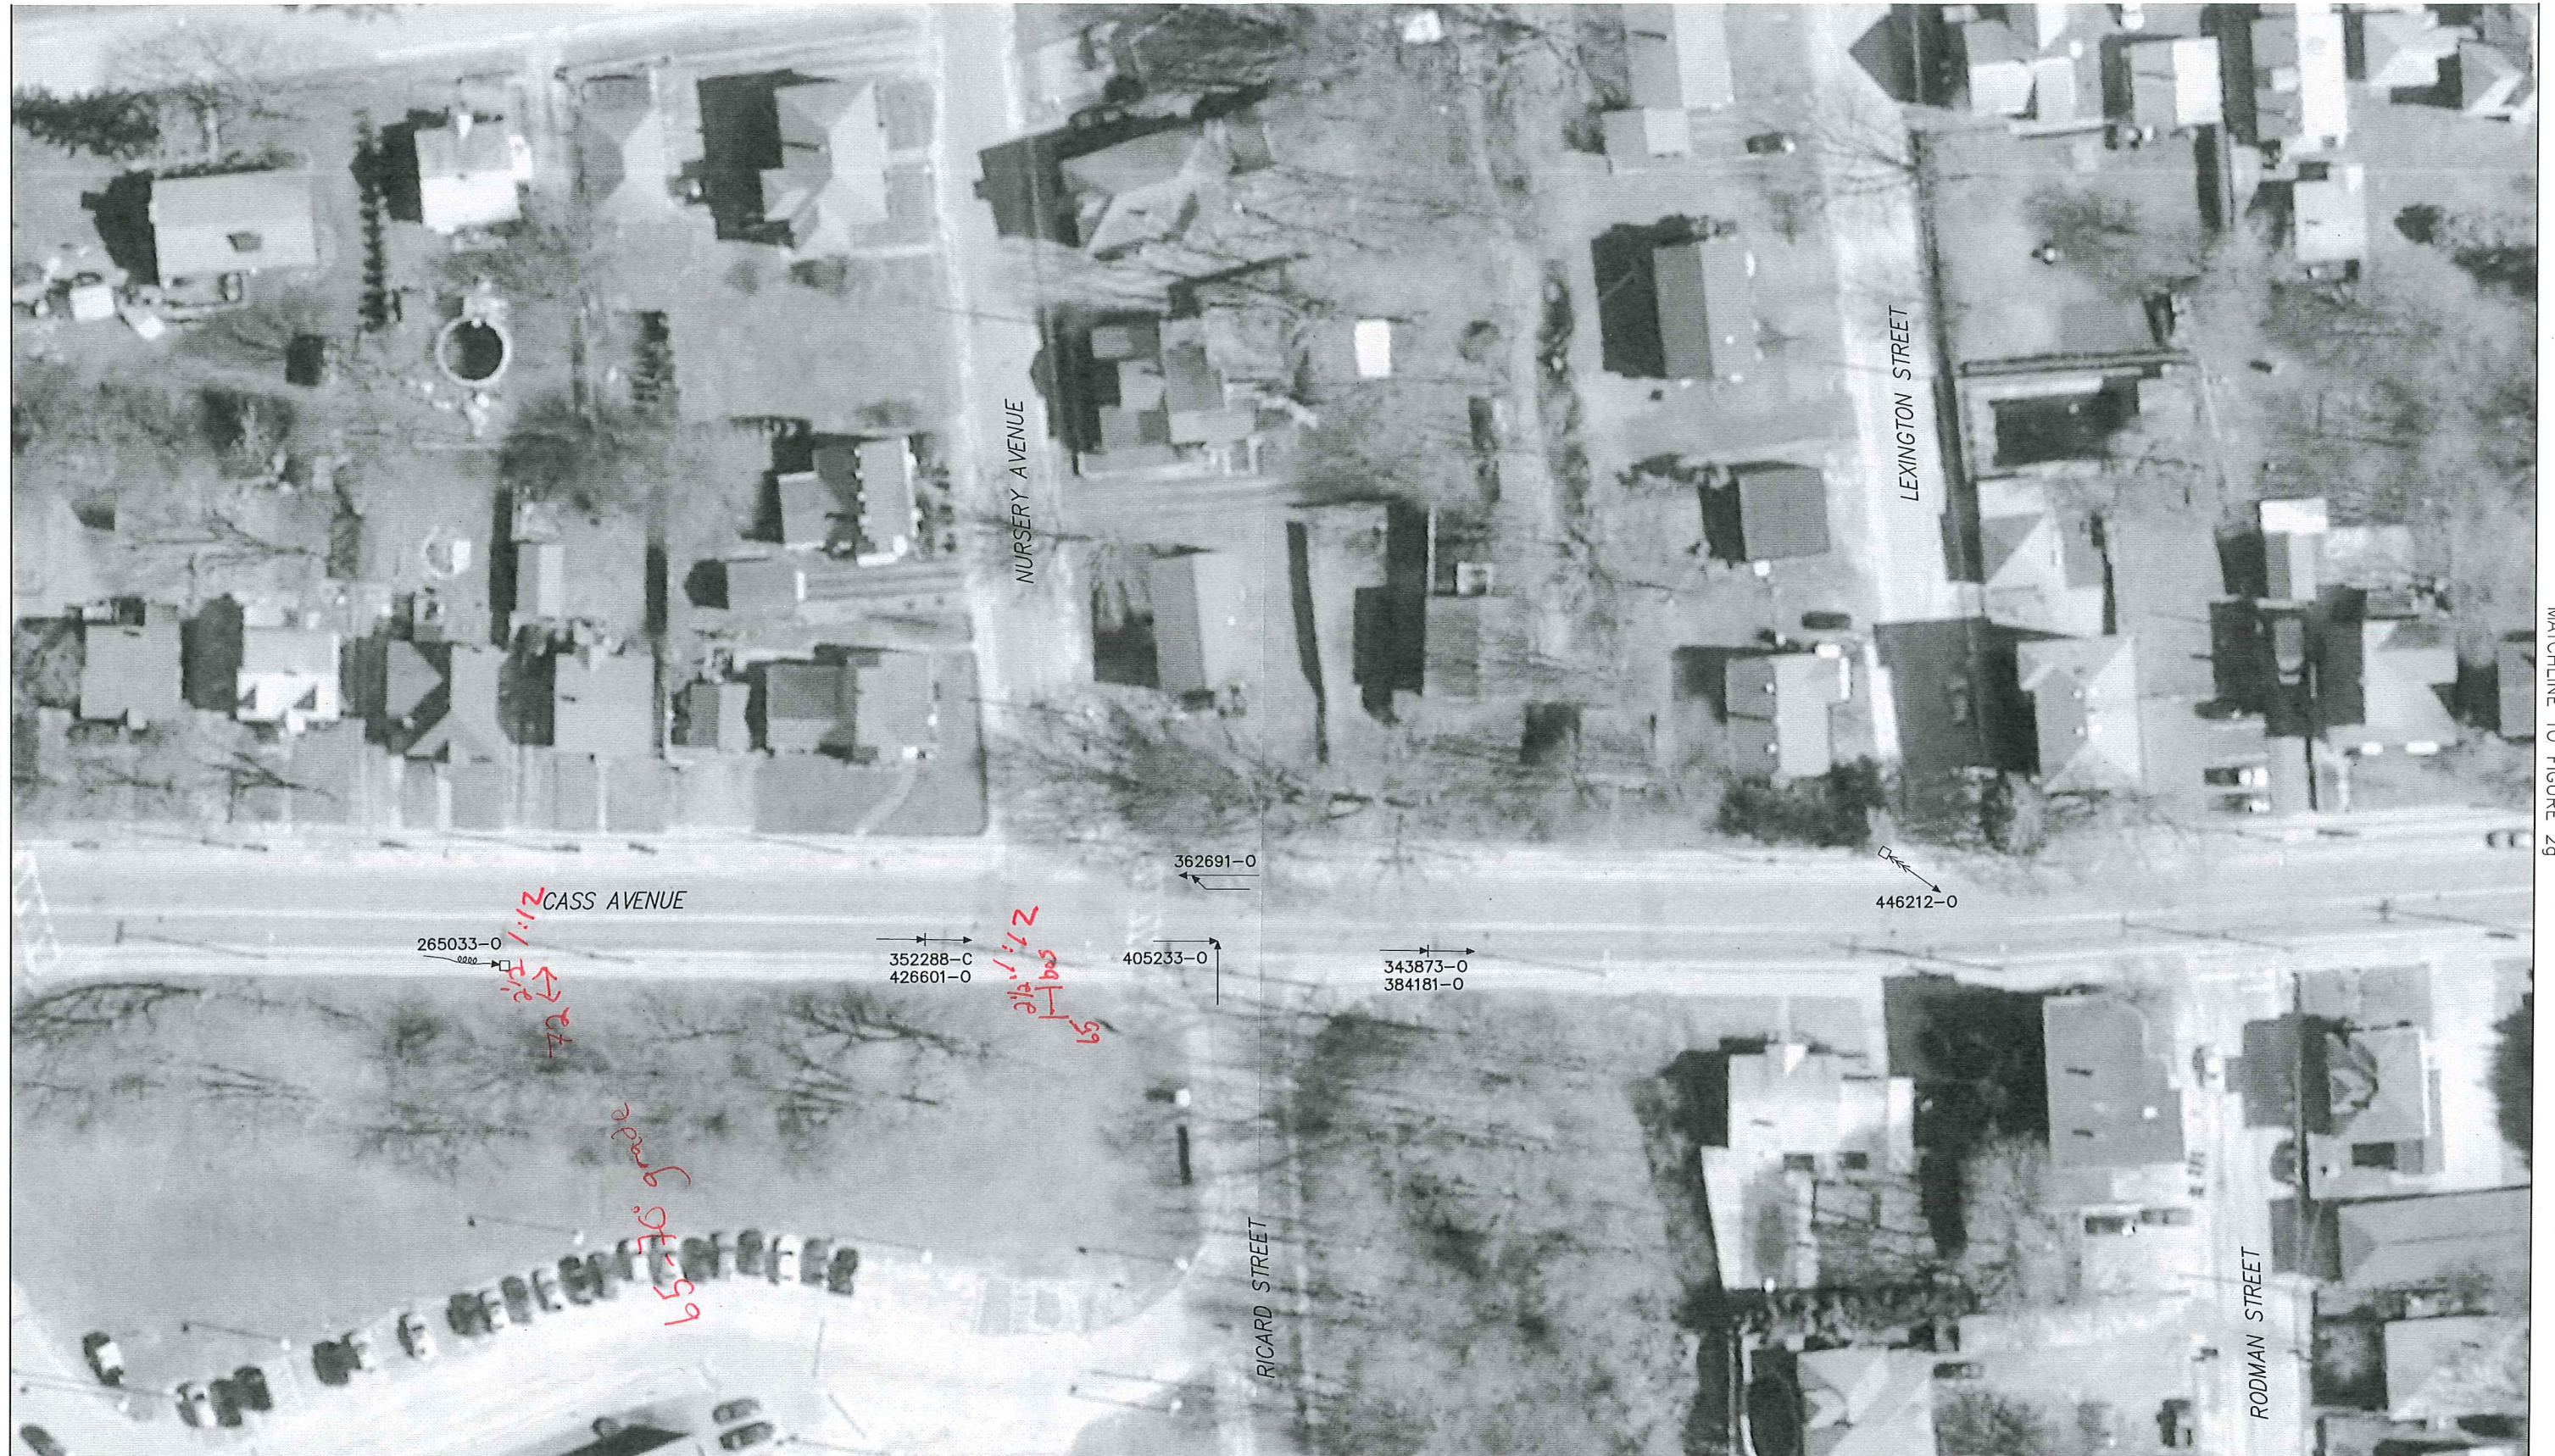
Figure 2-1f

SOURCE:  
CRASH DATA PROVIDED BY RIDOT TRAFFIC  
RESEARCH UNIT. CRASH DATA PROVIDED DATES  
FROM 2013 THROUGH 2017.
