# Road Safety Assessment

## Diamond Hill Road | Woonsocket, RI

SEPTEMBER 2020

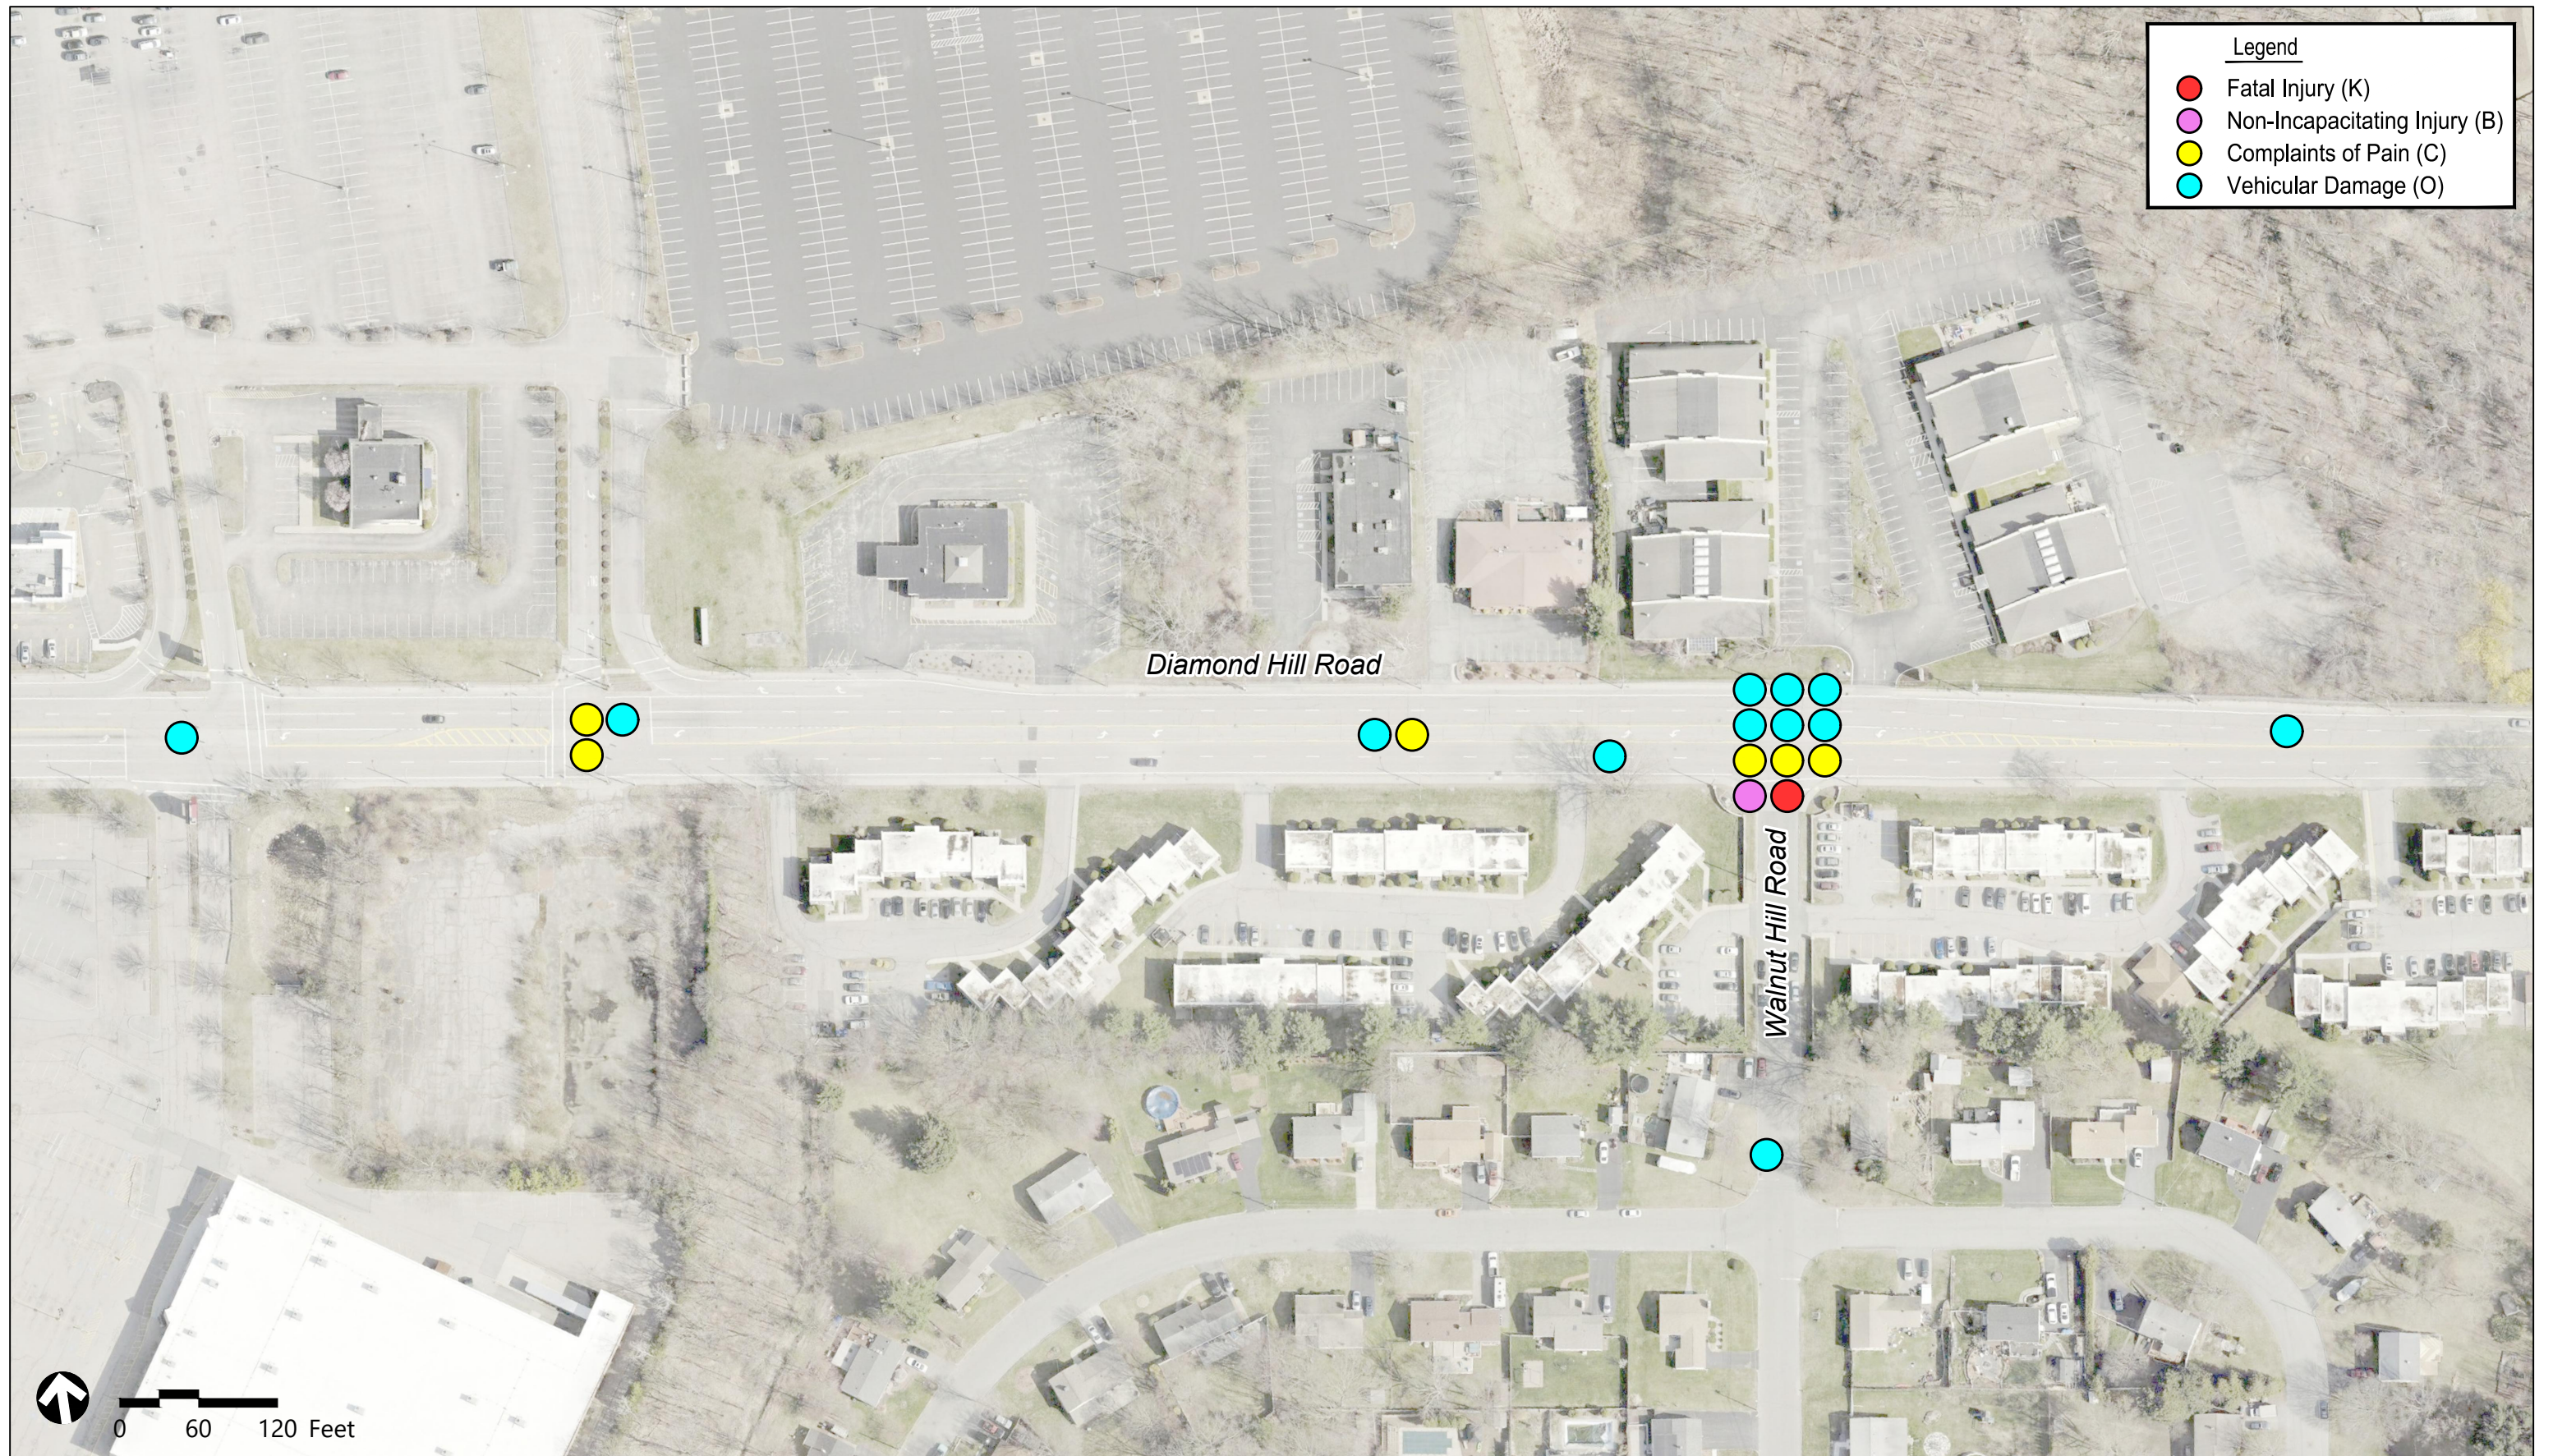
Figure 2-1

Source:  
2020 Aerial Photograph provided by RIGIS  
Crash data provided by RIDOT Traffic Research Unit.  
The dates of the crash data presented are 2015 through 2020.

Collision Summary  
Diamond Hill Road at Walnut Hill Road  
Woonsocket, Rhode Island

**Figures 2-1** presents the crash diagram for the study area.

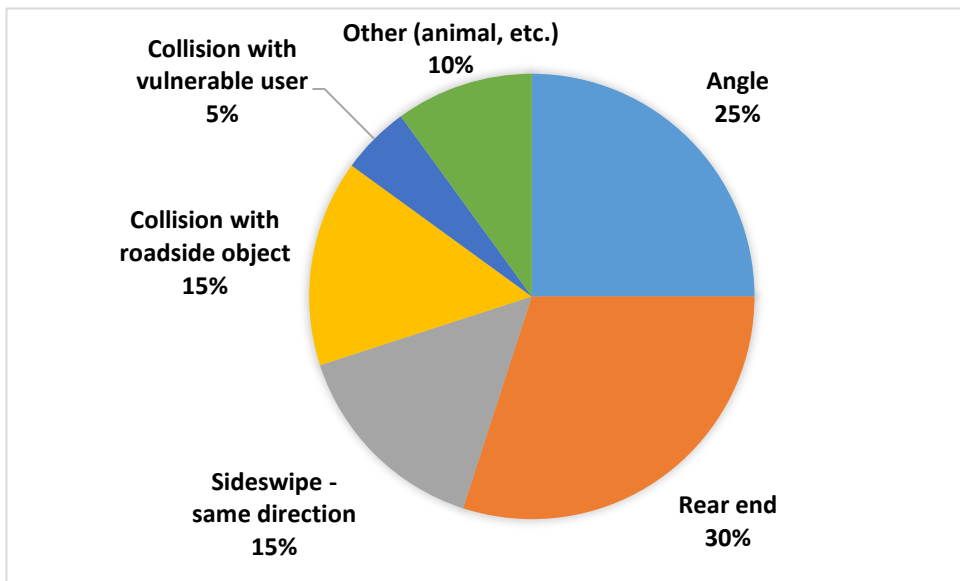
**Figure 2-3 Crash Type Summary for Diamond Hill at Walnut Hill Roads**

The majority of the crashes during this period were either angle crashes (25%) or rear end crashes (30%). Emphasis areas for the crashes during this period highlighted intersection related crashes, roadway departure crashes, crashes involving elderly drivers, and crashes involving vulnerable users. The category of vulnerable road users is comprised of pedestrians, cyclists and motorcycle operators. Of the two crashes involving vulnerable users, one of them involved a motorcycle and was a K-type crash, and the other one involved a go-kart and was a C-type crash. **Appendix A** provides a detailed summary of the crash data.

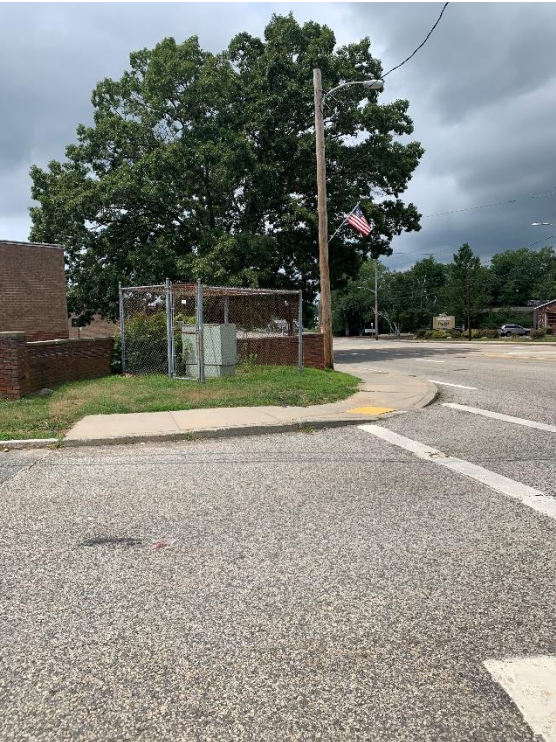
OBSERVATION	IMMEDIATE TERM IMPROVEMENTS Under 6 months	NEAR TERM IMPROVEMENTS Under 2 years	LONGER TERM IMPROVEMENTS Over 2 years	COMMENTS
<p><b>Poor Visibility Intersection</b> – Turning on to Diamond Hill Road from Walnut Hill Road is difficult due to multiple sight line obstacles blocking the view of oncoming traffic while stopped at the stop line and the general speed that cars are travelling along this roadway.</p>

<p><b>ENGINEERING:</b></p> <p><b>1.1</b> Consider installing an intersection warning sign on the Eastbound side of Diamond Hill Road an appropriate distance away from the intersection.</p>	<p><b>ENGINEERING:</b></p> <p><b>1.2</b> Coordinate with the owners of Walnut Hill Apartments about removing the brick wall on the southwest and southeast corner of the intersection and trimming the tree on the southwest corner in order to improve visibility for the intersection.</p> <p><b>1.3</b> Consider implementing a Road Diet on Diamond Hill Road, reducing the number of lanes from five to three, one lane for each direction and a center turn lane, creating an 8' shoulder on the sides.</p>	<p><b>ENGINEERING:</b></p> <p><b>1.4</b> Consider implementing a traffic signal control at the intersection of Diamond Hill Road and Walnut Hill Road.</p>	<p><b>The City of Woonsocket should work in conjunction with Walnut Hill Apartments in order to improve sight visibility by removing the brick wall and trees that are impacting the sight lines.</b></p> <p><b>An engineering study must be conducted in order to understand the feasibility of a road diet on Diamond Hill Road.</b></p> <p><b>Further research must go in to see if the intersection itself warrants a traffic signal based on traffic counts and other variables</b></p>

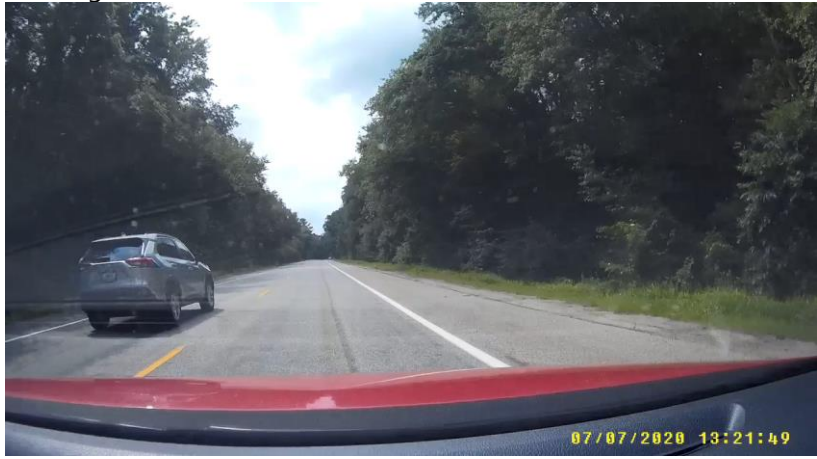
OBSERVATION	IMMEDIATE TERM IMPROVEMENTS Under 6 months	NEAR TERM IMPROVEMENTS Under 2 years	LONGER TERM IMPROVEMENTS Over 2 years	COMMENTS
<p><b>Speeding Vehicles</b> – Vehicles are travelling at a high rate of speed throughout the Diamond Hill Road corridor. Higher speeds can result in crashes of higher severity and inadequate gaps for vehicles entering the mainline of traffic.</p>

<p><b>ENFORCEMENT:</b></p> <p><b>1.5</b> Consider a speeding enforcement campaign on Diamond Hill Road to discourage speeding.</p> <p><b>ENGINEERING:</b></p> <p><b>1.6</b> Install dynamic speed feedback sign to discourage speeding along the corridor.</p> <p><b>1.7</b> Install new speed limit signs spaced more appropriately and remove existing signs, as needed.</p>		<p><b>ENGINEERING:</b></p> <p><b>1.8</b> If the Road Diet is considered as described in Item 1.3 and adequate time to evaluate has passed, consider reducing the roadway speed limit.</p>	<p><b>A speed study was conducted at the intersection</b></p>

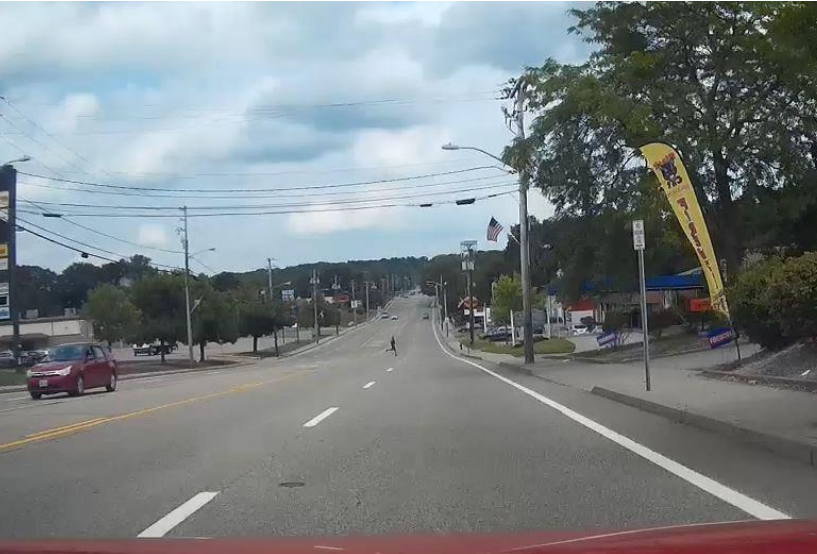
<p><b>Inadequate Vulnerable Road User Facilities and Accommodations</b> – A lack of available crosswalks on Diamond Hill Road forces pedestrians to cross the road outside of crosswalks. Given the width of the road and the speed at which vehicles travel on this road it is a hazard to the safety of pedestrians that need to cross the street.</p>

<p><b>EDUCATION:</b></p> <p><b>1.9</b> Consider a “Yield to Pedestrians” educational campaign to instruct drivers to yield to pedestrians in crosswalks.</p> <p><b>ENGINEERING:</b></p> <p><b>1.10</b> Review pedestrian signal equipment to identify and resolve any issues.</p> <p><b>1.11</b> Install continental style pavement markings at all marked crosswalks.</p>	<p><b>ENGINEERING:</b></p> <p><b>1.12</b> Reconstruct all non-compliant sidewalks and wheelchair ramps with an ADA compliant design at the intersection of Diamond Hill Road and Walnut Hill Road. Ensure no pinch points less than 36” and appropriate sidewalk slopes at the intersection. Incorporate these improvements into existing and future redevelopment projects.</p>	<p><b>ENGINEERING:</b></p> <p><b>1.13</b> Install rectangular rapid flashing beacons (RRFB) at uncontrolled crosswalks to enhance pedestrian visibility in key locations along the corridor.</p>	<p><b>1.12 Pending study conducted in 1.21</b></p>

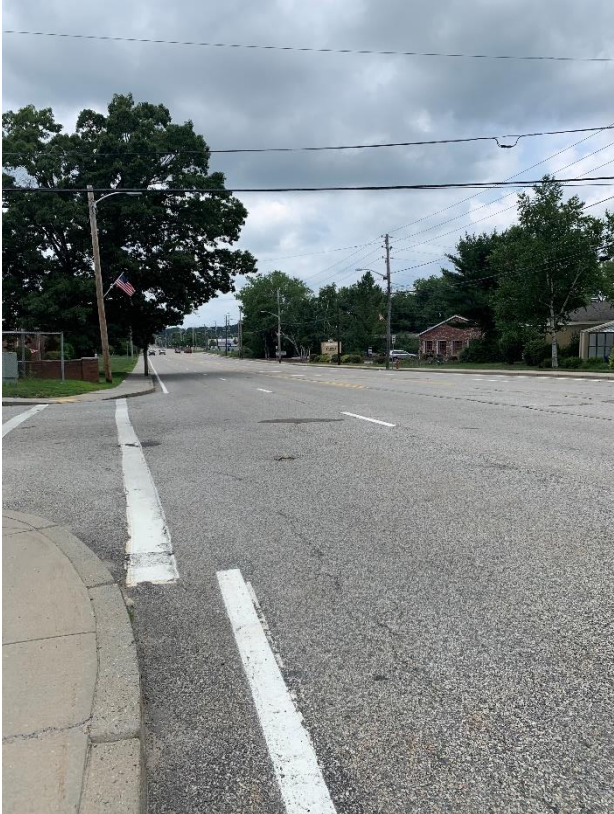
OBSERVATION	IMMEDIATE TERM IMPROVEMENTS Under 6 months	NEAR TERM IMPROVEMENTS Under 2 years	LONGER TERM IMPROVEMENTS Over 2 years	COMMENTS
<p><b>Bicycle Accommodations</b> – There are no marked bicycle lanes throughout this corridor of Diamond Hill Road.</p>

<p><b>EDUCATION:</b></p> <p><b>1.14</b> Consider an educational campaign to instruct drivers to watch for and share the road with cyclists.</p> <p><b>ENGINEERING:</b></p> <p><b>1.15</b> If a Road Diet is conducted, consider bicycle lane pavement markings and signage as described in Chapter 9 of the MUTCD in the newly formed shoulders.</p> <p><b>1.16</b> If bicycle lanes are implemented, provide enhanced pavement markings at signalized intersection to guide bicyclists through the intersection and driveways.</p>	<p><b>ENGINEERING:</b></p> <p><b>1.17</b> Revise City of Woonsocket Comprehensive Plan to include bicycle accommodations.</p>	<p><b>ENGINEERING:</b></p> <p><b>1.18</b> Consider developing a City bicycle plan.</p>	<p><b>All bicycle related actions are contingent on implementing a road diet along Diamond Hill Road and approval from the City of Woonsocket</b></p>

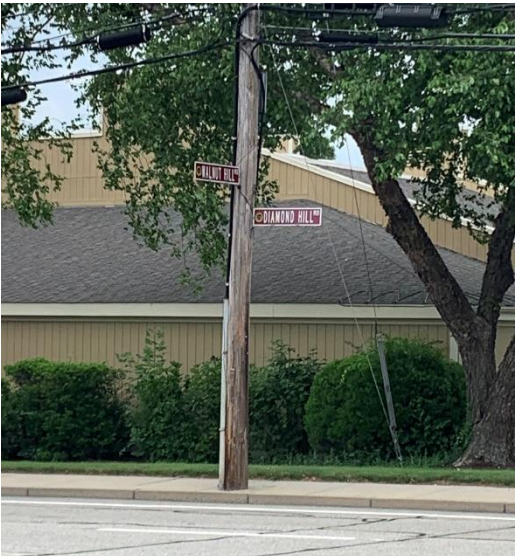
<p><b>Inadequate signage</b> – Traffic sign clutter along the corridor has the potential for increased driver workload and may be confusing for drivers. Existing signage in the area was found to be damaged, obstructed or missing.</p>

<p><b>ENGINEERING:</b></p> <p><b>1.19</b> Conduct a comprehensive traffic sign audit to verify sign size/height, retro-reflectivity, current sign standards, consistency, redundancy, and unnecessary signs. Revise signs accordingly.</p> <p><b>1.20</b> Exposed traffic sign breakaway posts should be removed or repaired, as necessary.</p> <p><b>1.21</b> Inventory existing sidewalk and wheelchair ramp condition.</p>			<p><b>Since the completion of the Road Safety Assessment, corridor videos were acquired.</b></p>
